Navajo Abandoned Uranium Mine

Site Screen Report

NA-0316 AUM Site

Navajo AUM Northern Region

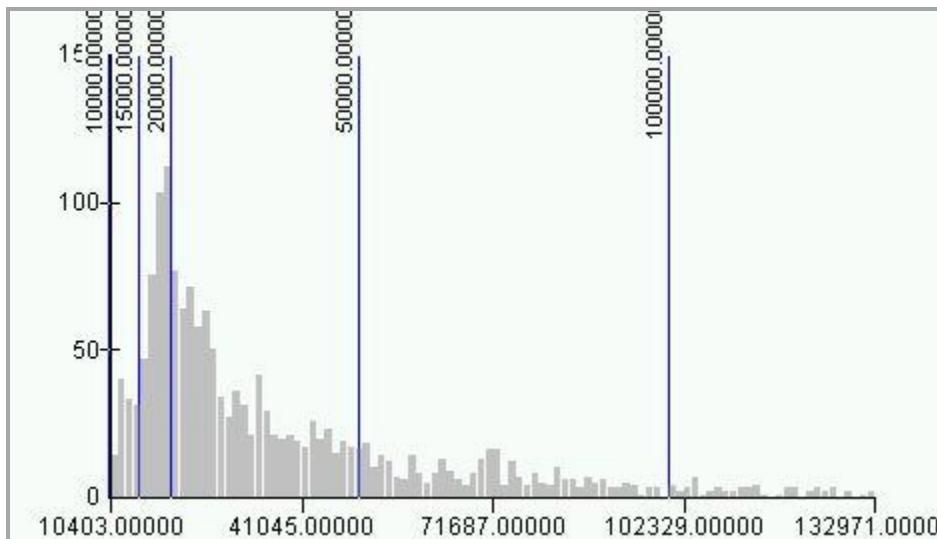
The following chart and statistics were generated by ESRI ArcGIS 9.3.1, and show the general distribution of the site gamma radiation measurements. The horizontal X axis represents the gamma radiation reading levels in cpm (lowest levels to the left). The vertical Y axis represents the frequency of each gamma radiation level.

Count:	1646
Minimum:	10403.00000
Maximum:	132971.00000
Sum:	61186394.00000
Mean:	37172.77886
Median:	27162.50000
Standard Deviation:	24593.47314

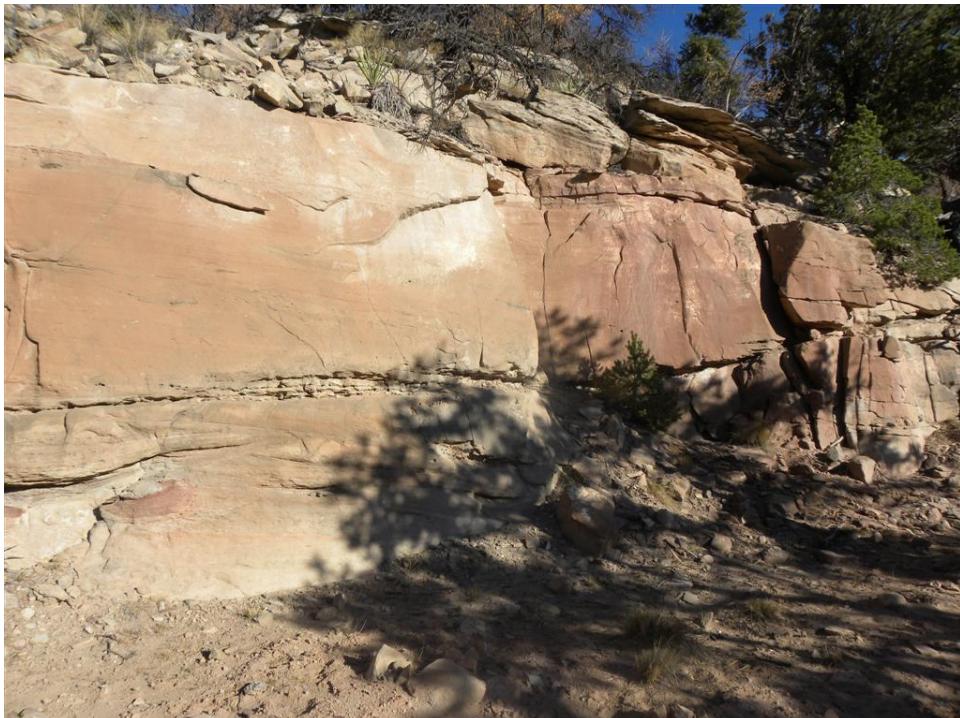
2 waste piles washed down into valley, 100' x 50'; 50' x 50'; with a total estimated volume of 1,389 yd³

Photo 1. Waste debris

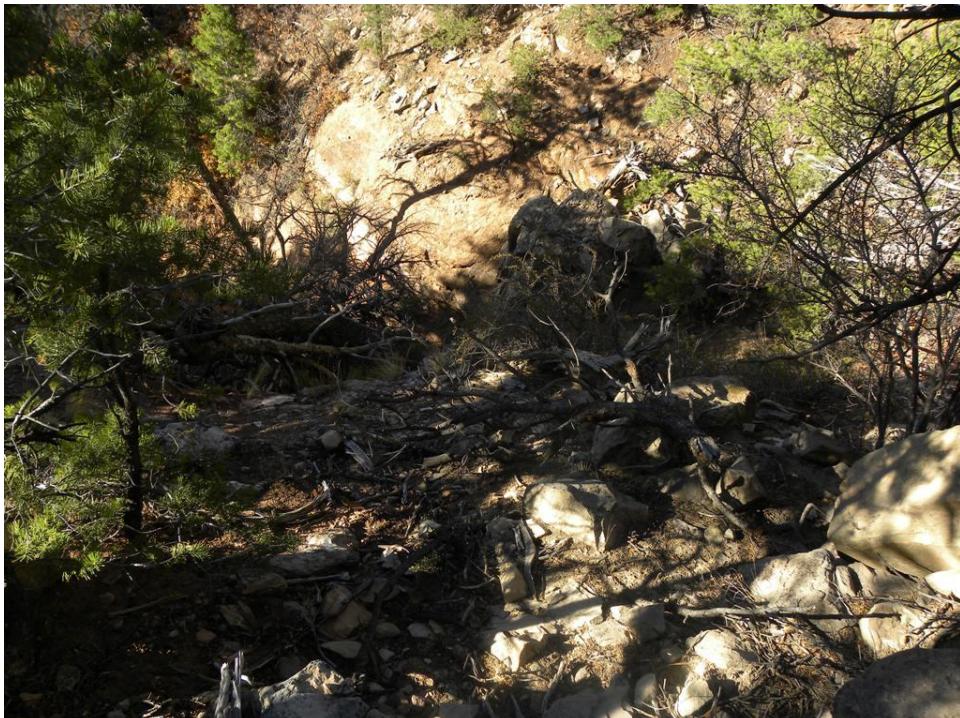
Photo 2. Waste debris down slope

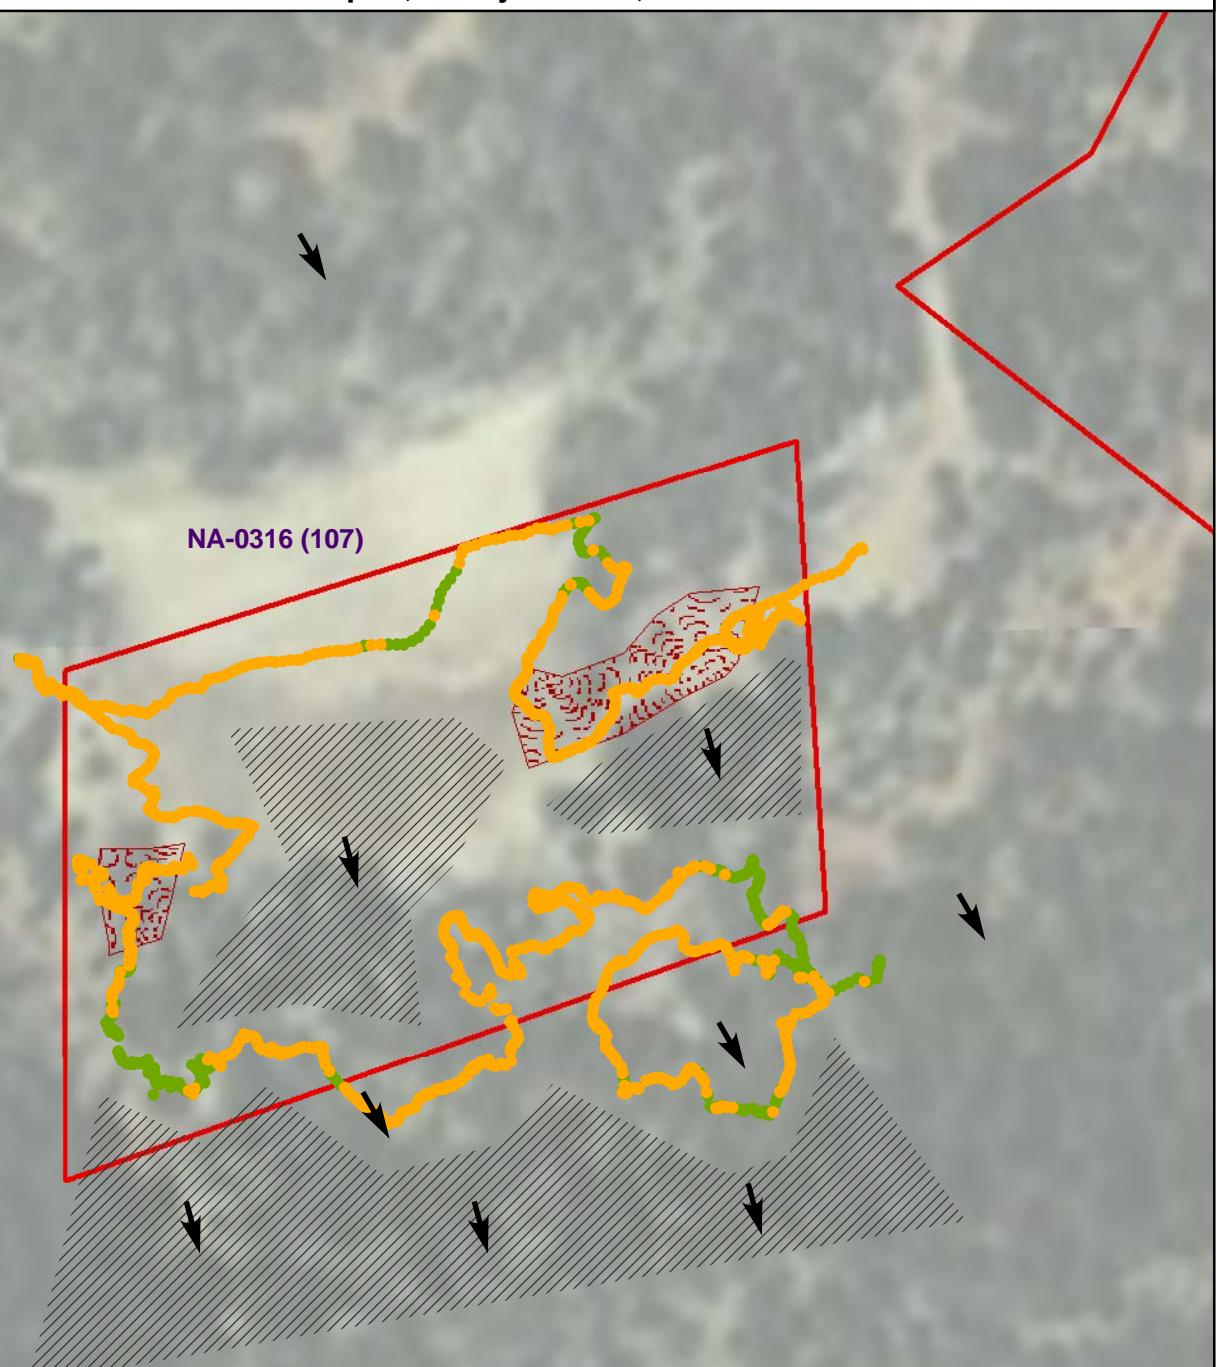
Figure 1 - Gamma Radiation Measurements, Above Two Times Background
 NA-0316 (107)
 Cove Chapter, Navajo Nation, Arizona

A total of 1,646 gamma radiation measurements were collected from the mine site, ranging from 10,403 cpm to 132,971 cpm. Measurements in the vicinity of the medium waste debris pile were found at levels of approximately 133,000 cpm at top, and 30,000 cpm at the bottom, and levels at the larger waste pile of approximately 70,000 cpm. The measurements are represented in Figures 1 and 2.
